# Traffic Technology تکنولوجیا حرکة المرور

## **Drive Assisting Delineators (DADs)**

# Tunnel Inspection فحص الأنفاق

## **Expressway Inspection & Diagnosis** التفتيش والتشخيص

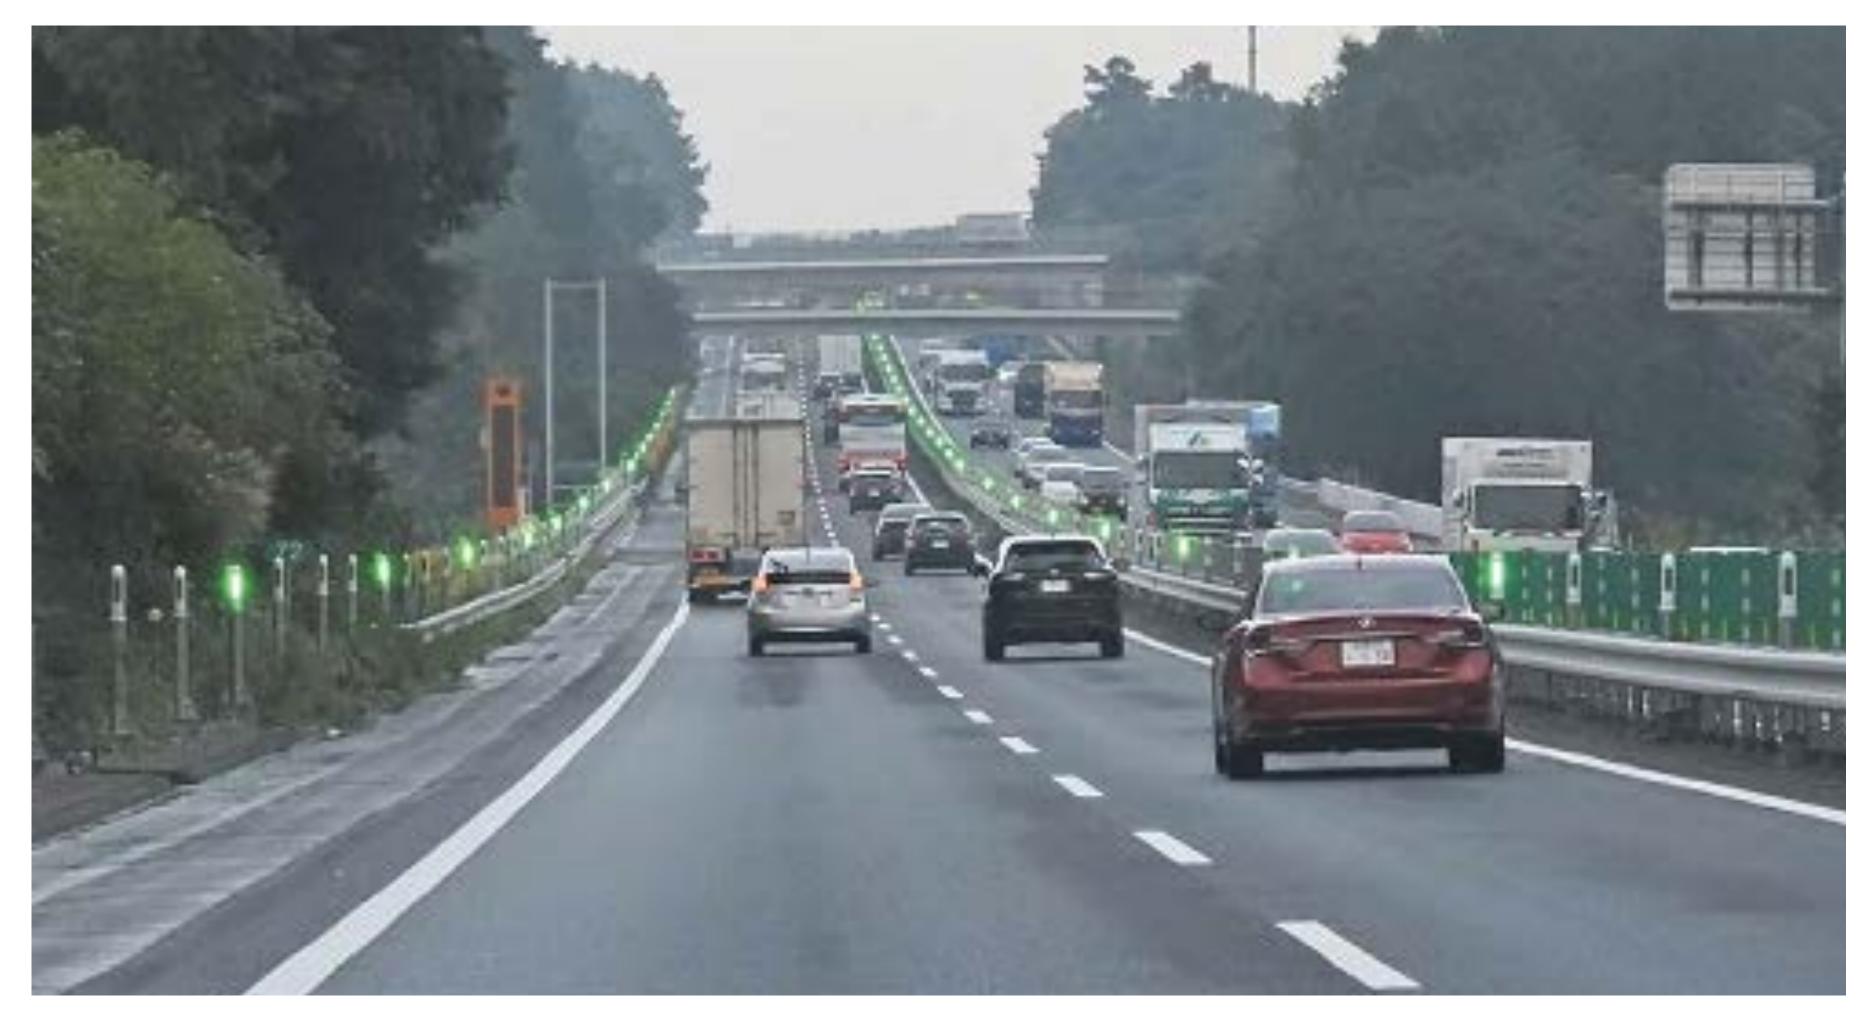
## DADs contribute to traffic congestion mitigation

DADs provide the lighting flows along the road
 Drivers instinctively maintain steady speeds or restore their speeds with the DADs flows

- $\checkmark$  Minimize or restraint congestion occurrences when traffic is busy
- ✓ Facilitate restoring traveling speed when traffic is congested
  ✓ Automatic control on best suitable lighting patterns based on (real-time) traffic conditions
- Applicable to congestion multiple bottlenecks

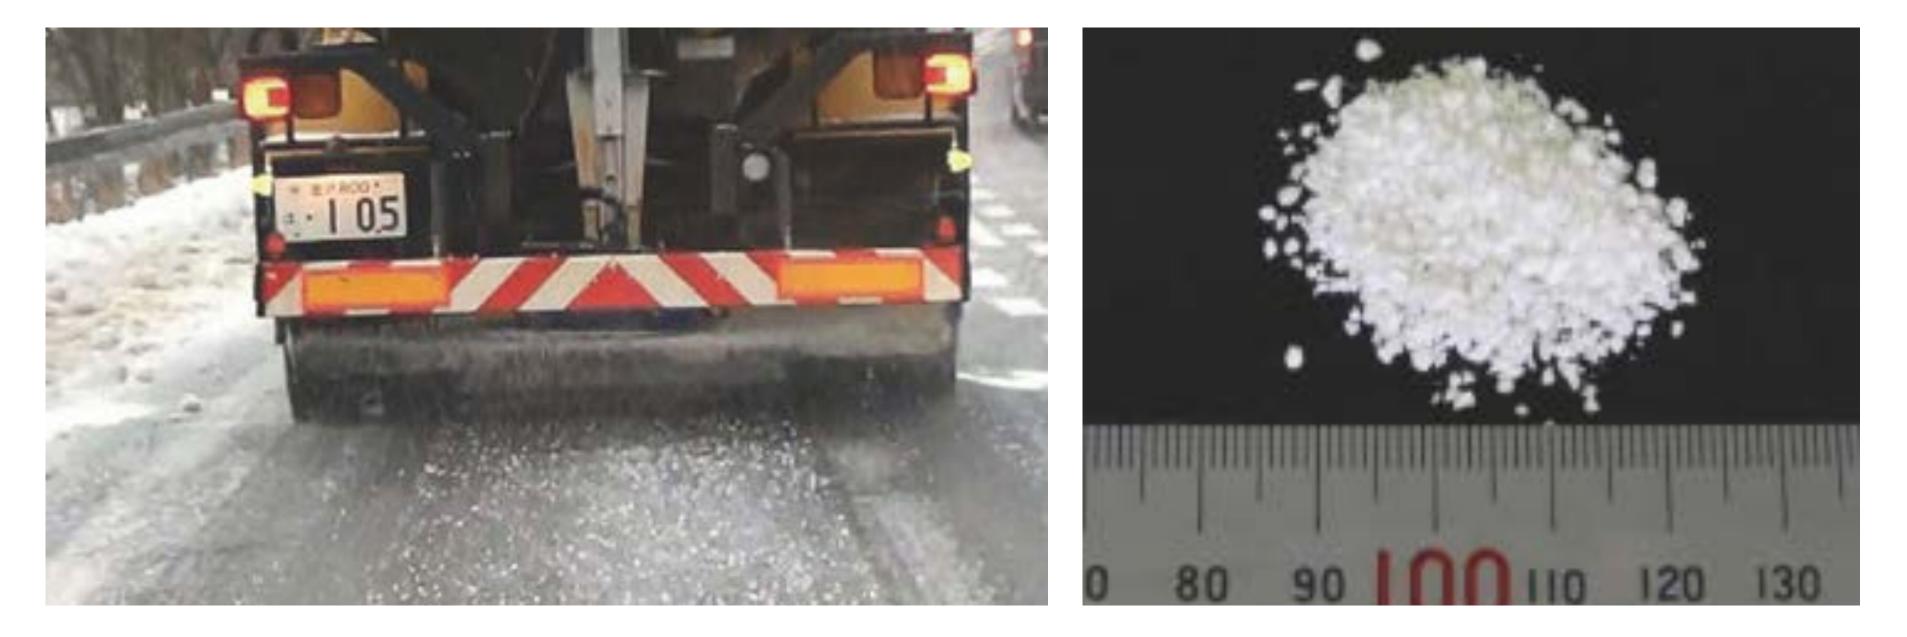
## Alternatives! "Sodium Propionate"

- $\checkmark$  A 1:9 ratio of sodium propionate to sodium chloride
- $\checkmark$  As effective as sodium chloride
- Causes as little damage to road structures as rainwater may cause
- ✓ Can be used for any road structures, including bridges, with existing wet-salt spreaders or brine spreaders

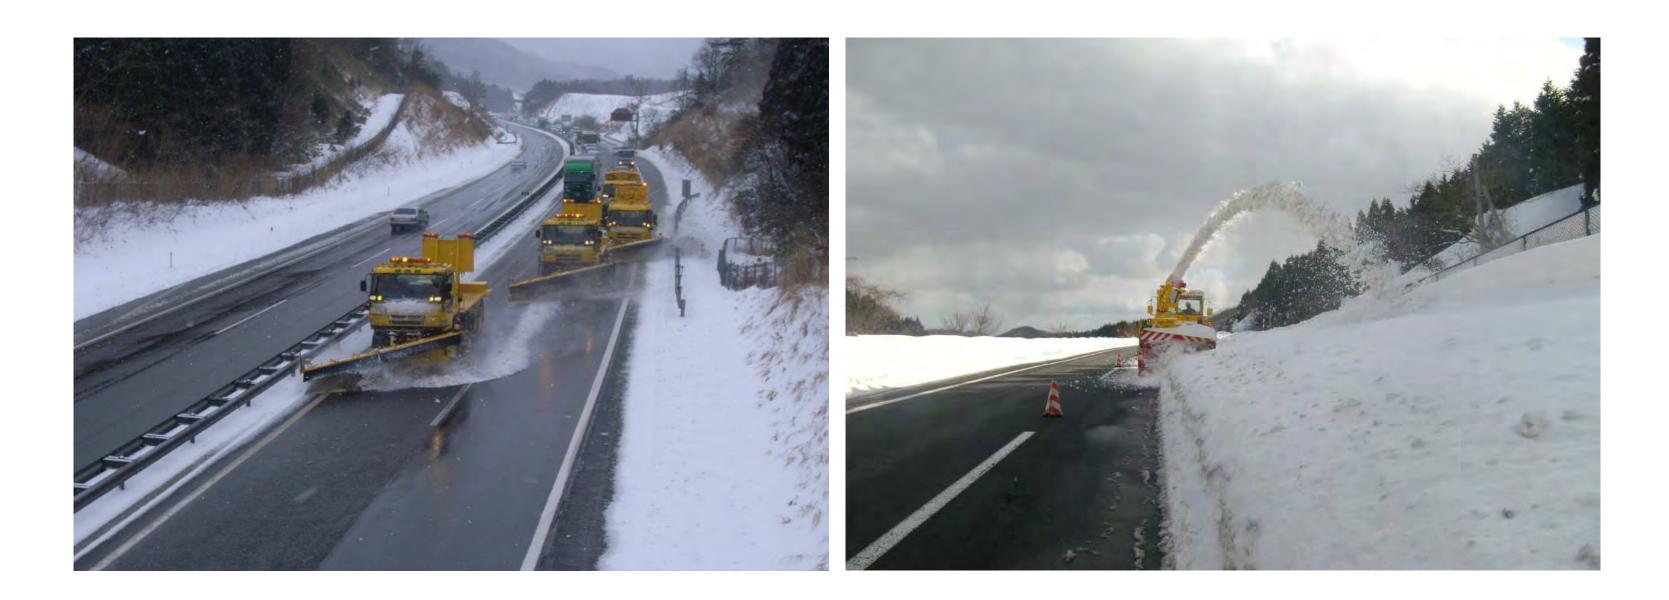
Severe environment in snow region

- ◆ At least 40% of the total expressways-length has been operated for more than 30 years and because of this, the expressways are seriously deteriorated.
- ◆ At least 40% of the total bridge-length and 20% of total tunnel-length were also constructed more than 30 years ago and they are facing increased risk by the aged deterioration.
- The total vehicle weight is increasing with the increase in the number of large-scale vehicle on the expressways. The expressways are under severe conditions such as increasing in the usage of anti-freezing agent (NaCl) and the increase in the amount of extreme rainfall for a short time.

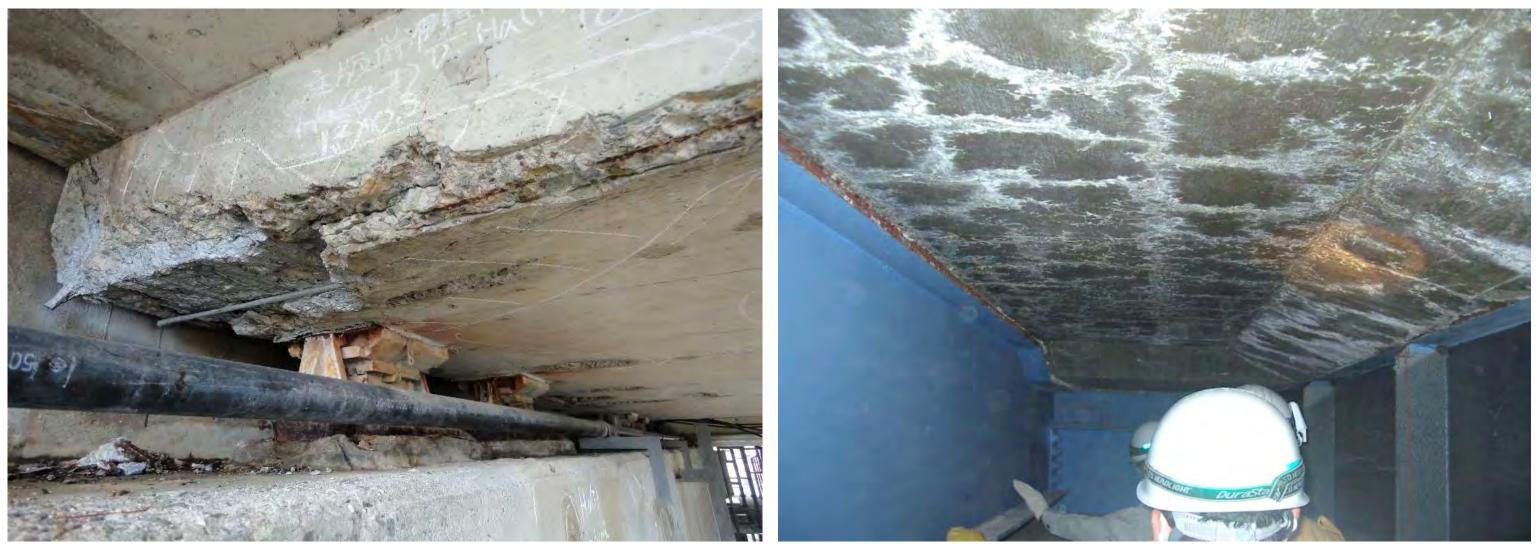
**Concrete cracks and float**

**Concrete free lime**

**Damaged Condition**

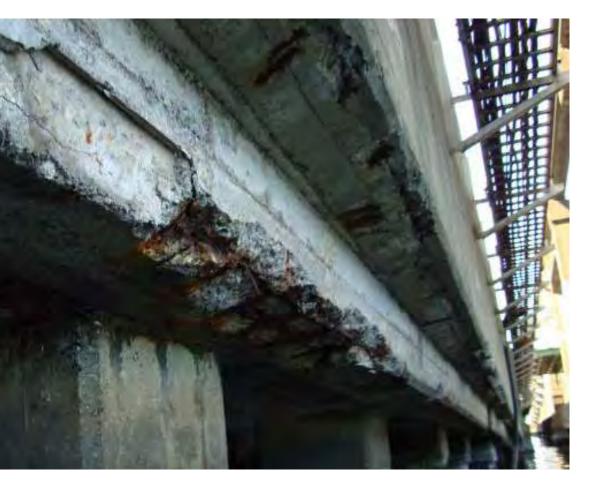
Deteriorated Structure (2014)

#### e.g. Replacement of RC concrete slab with PC precast slab

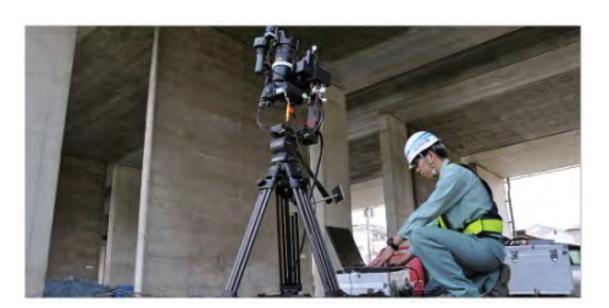
**Bridge inspection using** Infrared Camera System

The infrared camera system takes images which is analyzed automatically and displays the damage level in three stages. Because damages are objectively analyzed by software, bias or oversight in measuring caused by skill difference can be prevented. In addition, this system helps to create a research report since the detected results are easily captured on spreadsheets or word processing software. This system has gotten track records in the U.S.

Infrared thermal image

Damage is detected by computer analysis

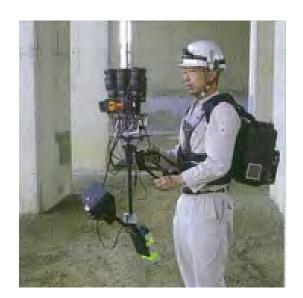
Video Camera System

High definition images taken by digital camera or video camera makes it possible to inspect the surface of a structure in the same way as the close visual inspection. Through a computer analysis of the images, the clacks are automatically detected.

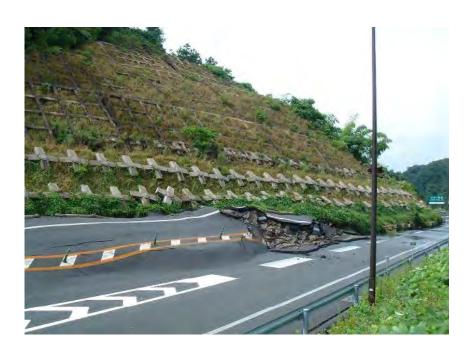
Ground anchor

New type of anchor installation filling up traditional anchor with inadequate anticorrosion function **Existing conventional**

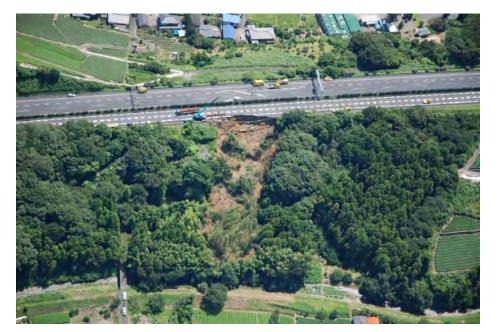
Aug. 11<sup>th</sup> 2009

Immediately after the Surugawan earthquake, NEXCO-Central started emergency checkup and stopgap recovery, and 4 days later, finished temporary recovery for general traffic.
