**ROAD MANAGEMENT SYSTEM IN ADVERSE WEATHER
CONDITIONS: FOG AND WIND
XXVII ROAD WORLD CONGRES
PRAGA, CZECH REPUBLIC, 02-06 OCTOBER 2023**

This article describes the protocols applied, the equipment systems installed to comply with these protocols and the effect these systems have had on the operability and safety of this affected section of the A-8.

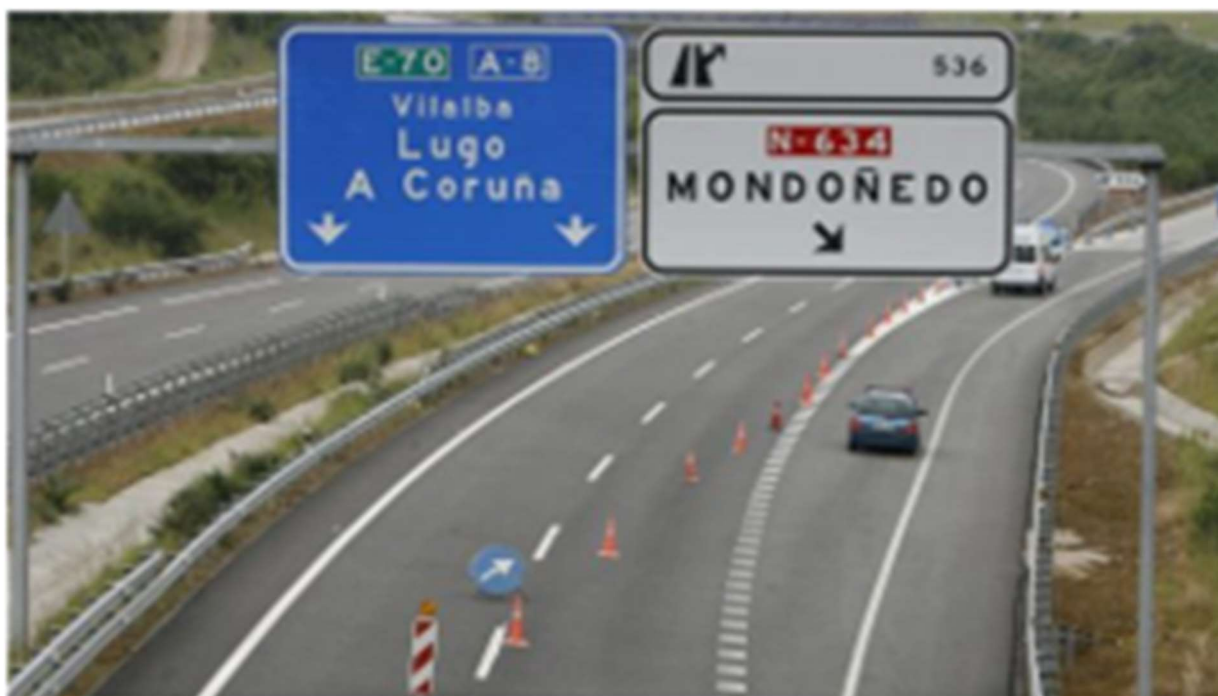
Figure 4 - Manual detour by means of physical lane markings on A-8.

Initially, the detour due to the presence of fog/wind was carried out manually, so that each activation of the detour was notified to the Piedrafita Tunnel Control Centre, which in turn notified the Integral Maintenance of the Mondoñedo area (Lugo) under the Ministry of Transport, Mobility and Urban Agenda, which was responsible for signalling and making the detour effective. This procedure, in addition to entailing considerable time between communications and coordination of personnel, also increased risk situations, by having agents on the road in charge of signalling and allowing vehicles to pass in foggy conditions while the detour was being made effective.

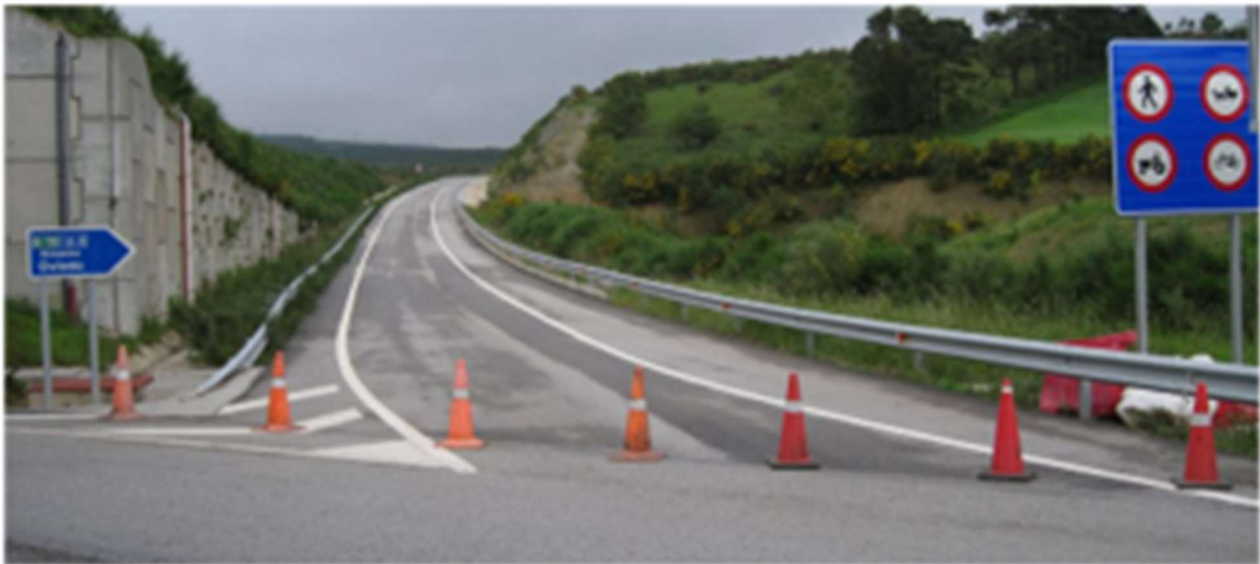
Figure 5 - Manual detour by means of physical signalling on access to A-8

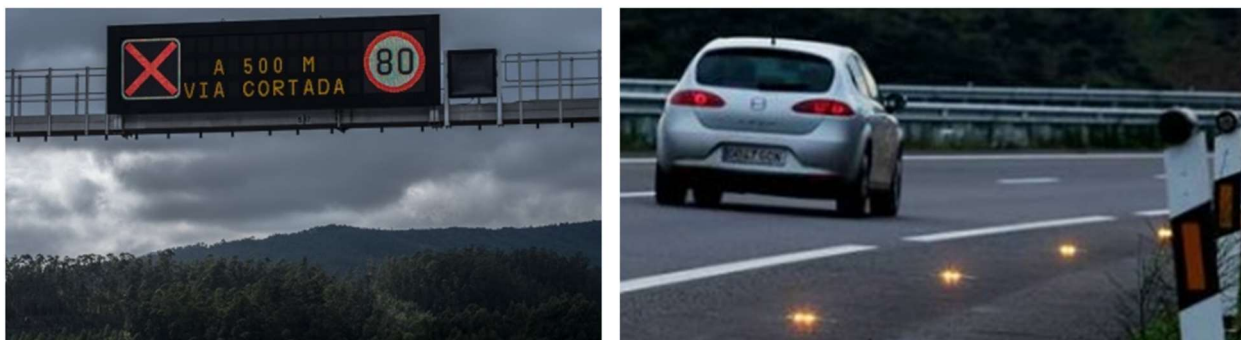
Figure 8 – Variable Message Sign and pavement markings. A-8 Motorway. Alto del Fiouco (Lugo). Spain

- Signalling panels: Once low visibility or high wind speeds have been detected, the corresponding speed limits, or the closure of the road and detour to the N-634, are signalled from the North-West - Cantabrian Traffic Management Centre. The corresponding warnings to drivers are displayed on the Variable Messaging Signs (VMSs) installed at the beginning and end of the section. In addition, the luminous beacons installed on the pavement are lit to direct vehicles, as shown in the following figures.

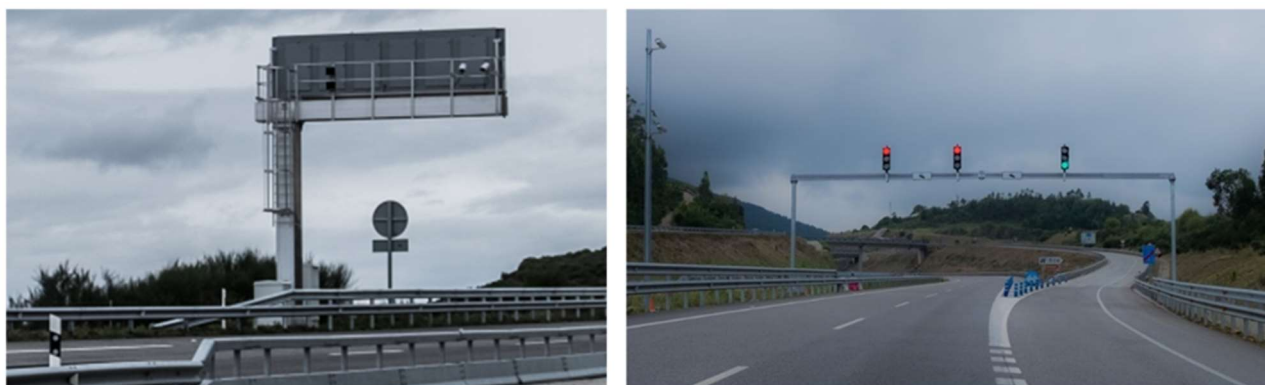
Figure 9. Variable Message Sign and traffic lights with red light cameras. A-8 Motorway. Alto del Fiouco (Lugo). Spain

- Control: In addition, to ensure that vehicles comply with speed restrictions, two speed cameras have been installed, as well as traffic lights equipped with red light cameras at the motorway's detour points.

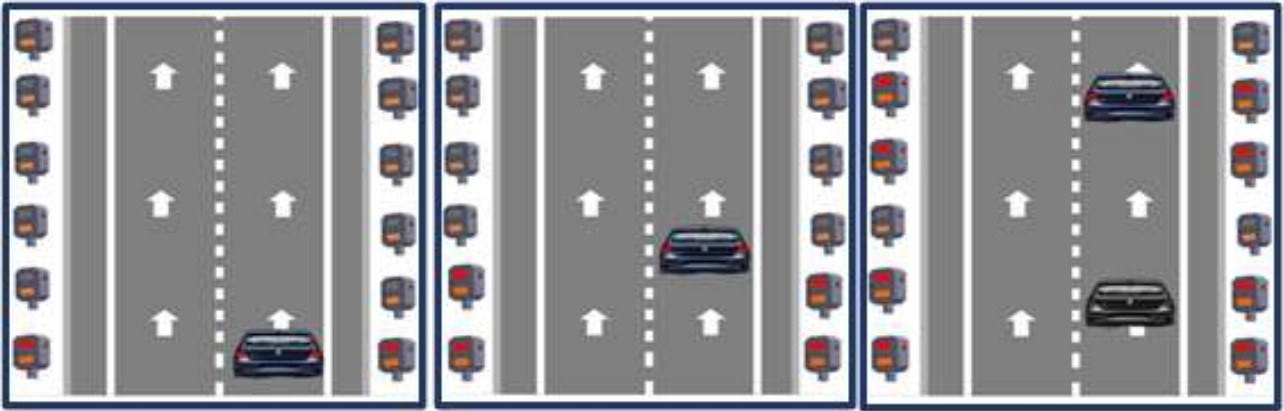
Figure 10 - Diagram of the operation of detector beacons in low visibility conditions. A-8 Motorway. Alto del Fiuoco (Lugo). Spain

As a complementary method to the automated detour, a system of beacons has been implemented to detect the presence of vehicles in low visibility conditions. Similar to the cantonisation of railway tracks, the beacons are installed on both sides of the road, 50 metres apart, and their function is to warn drivers of the presence of other vehicles on the road in low visibility conditions, so that they can adapt their speed and keep their distance from other vehicles.

The system of beacons for the detection of vehicles in low visibility conditions has already been put into operation on the O Fiouco stretch along a length of 4.28 km. The following images show how it works. In the presence of dense fog, with visibility less than 150 metres (yellow level), the lower amber lights of all the beacons installed on the stretch are activated to alert vehicles to the situation. Then, as soon as a vehicle enters this zone, the upper red light of the beacons closest to the vehicle on both sides is switched on to warn the following vehicle that another vehicle is travelling on the stretch. As the vehicle advances along the stretch, the following beacons are lit, and those 100 metres away from the vehicle are switched off. In this way, each vehicle has two beacons lit from behind, alerting road users that, in the next 100 metres, there is another vehicle driving ahead and that they should adapt their speed and keep their distance.

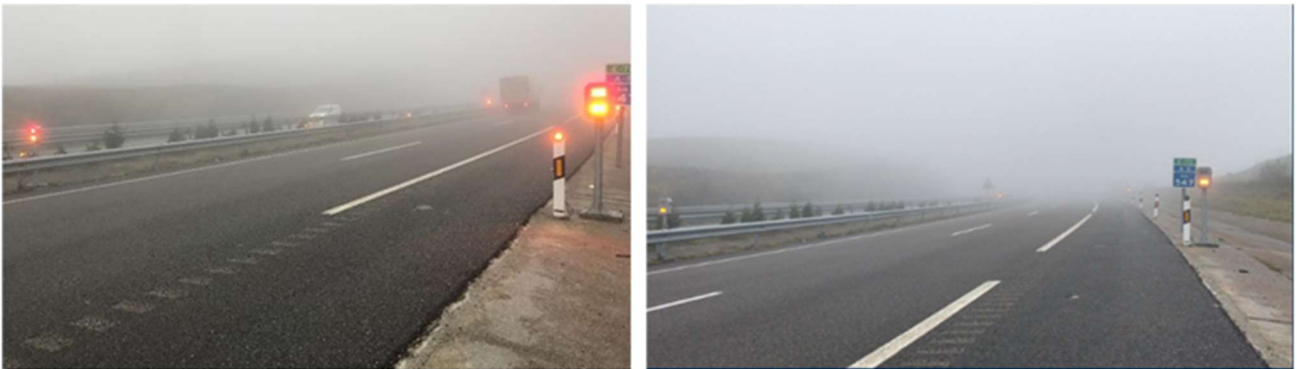
Figure 11 - Detector beacons in low visibility conditions. A-8 motorway. Alto de O Fiuoco (Lugo). Spain

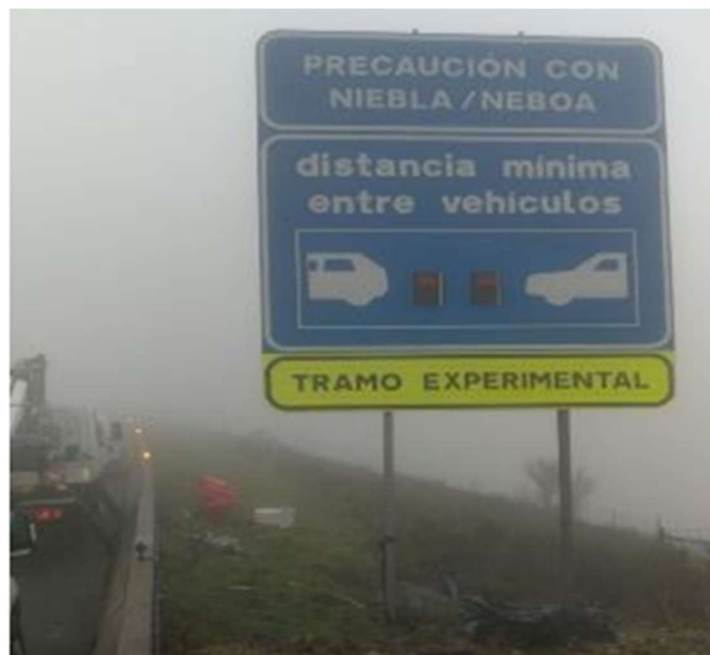
Figure 12 - Vertical sign located at the beginning of the section. Alto de O Fiuoco (Lugo). Spain

In order to inform drivers of the meaning of these beacons, so that they proceed with caution instead of stopping at a red signal, vertical signs explaining the system have been installed at the beginning of the section.
