# Chugoku Expressway Renewal Project

## Projet de renouvellement de l'autoroute Chugoku

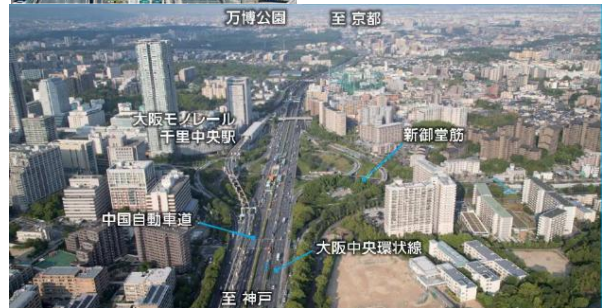
### Bridge Deterioration

- ❑ This section was constructed just **before the 1970 Osaka Expo** (about 50 years old).
- ❑ This area has been urbanized in the last 50 years, and our bridges became deteriorated.
- ❑ Development of motorization has led to an increase in large-vehicle traffic, and deregulation has led to an increase in the total weight of vehicles.
- ❑ Additionally, highways are exposed to harsh conditions, such as salt damage caused by anti-icing agents (sodium chloride) sprayed on road surfaces.

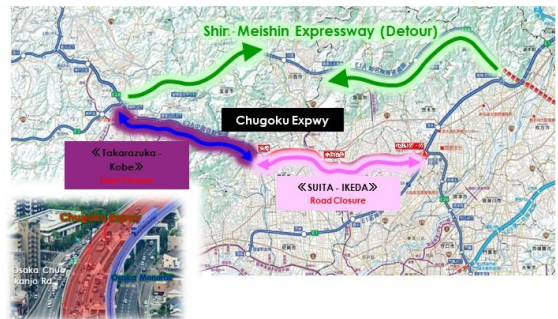
- ❑ Waited for the completion of the **parallel Shin-Meishin Expressway** before proceeding with the Chugoku Expressway Renewal project **to secure an alternate route.**

- ❑ Conventional deck replacement methods would cause **serious traffic congestion.**
- ❑ **100-day road closures** between Suita IC and Ikeda IC were performed for 2 years, while the Shin-Meishin Expressway and local road parallel to Chugoku Expressway served as **detour routes.**
- ❑ For a 6-lane section between Ikeda and Kobe cities, **two lanes for each direction** were secured during the construction.

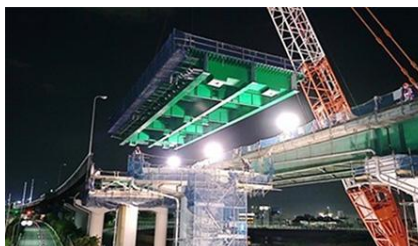
Deck Replacement by a Gantry Crane (at Low Clearance)

- ❑ Several countermeasures to reduce traffic regulation time were implemented.

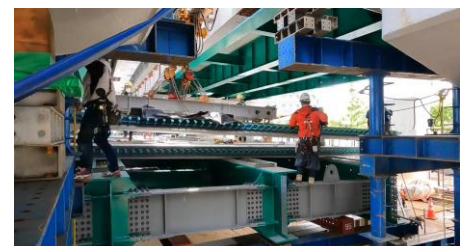
Erection by a Crane
