Corrosion

Advent of Performance-based Specifications

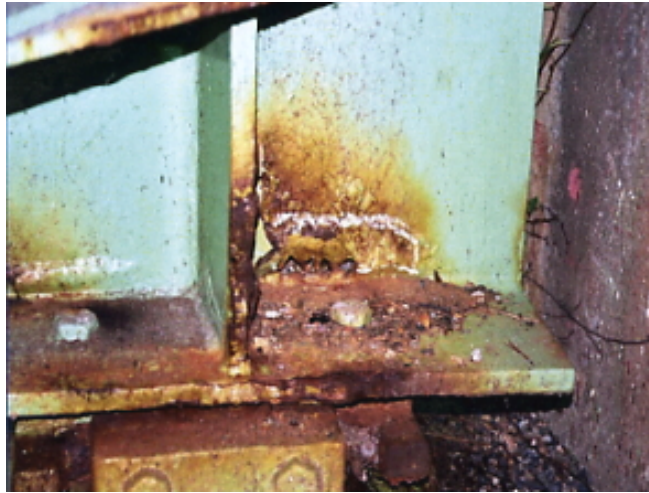
Local corrosion on girder edge

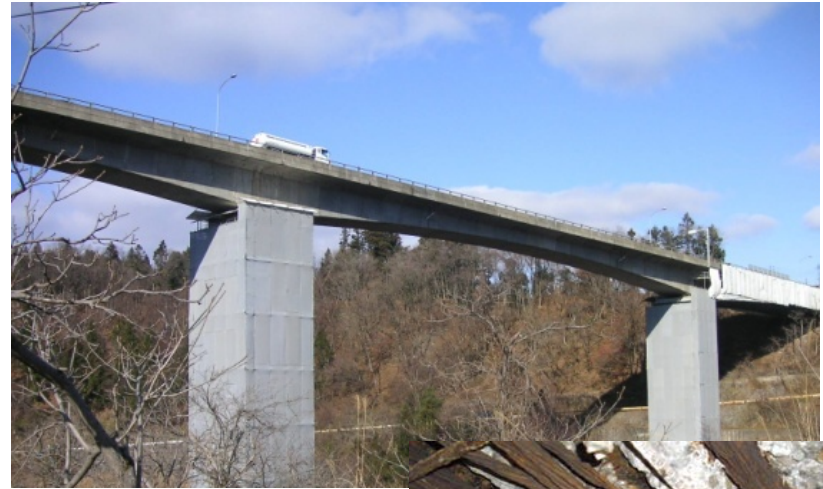
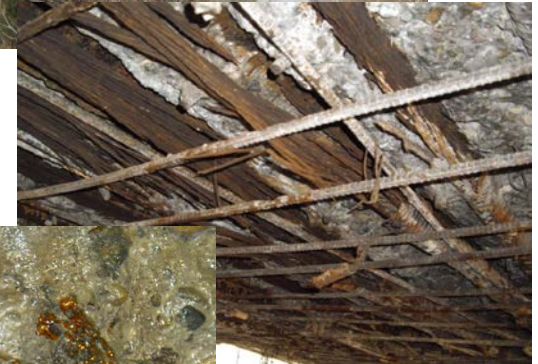
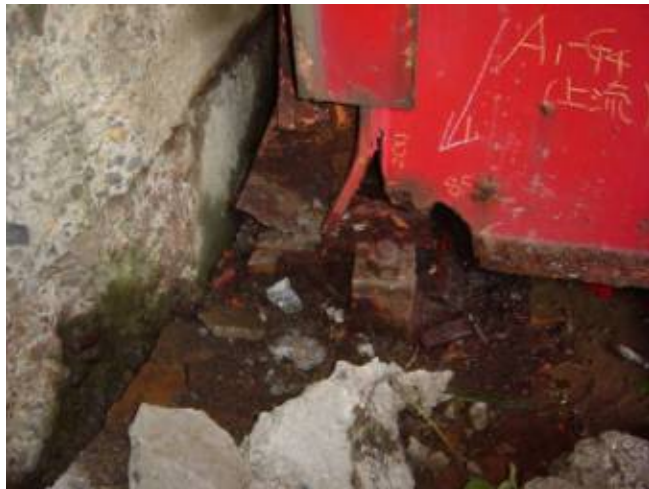
Broken girder edge due to corrosion

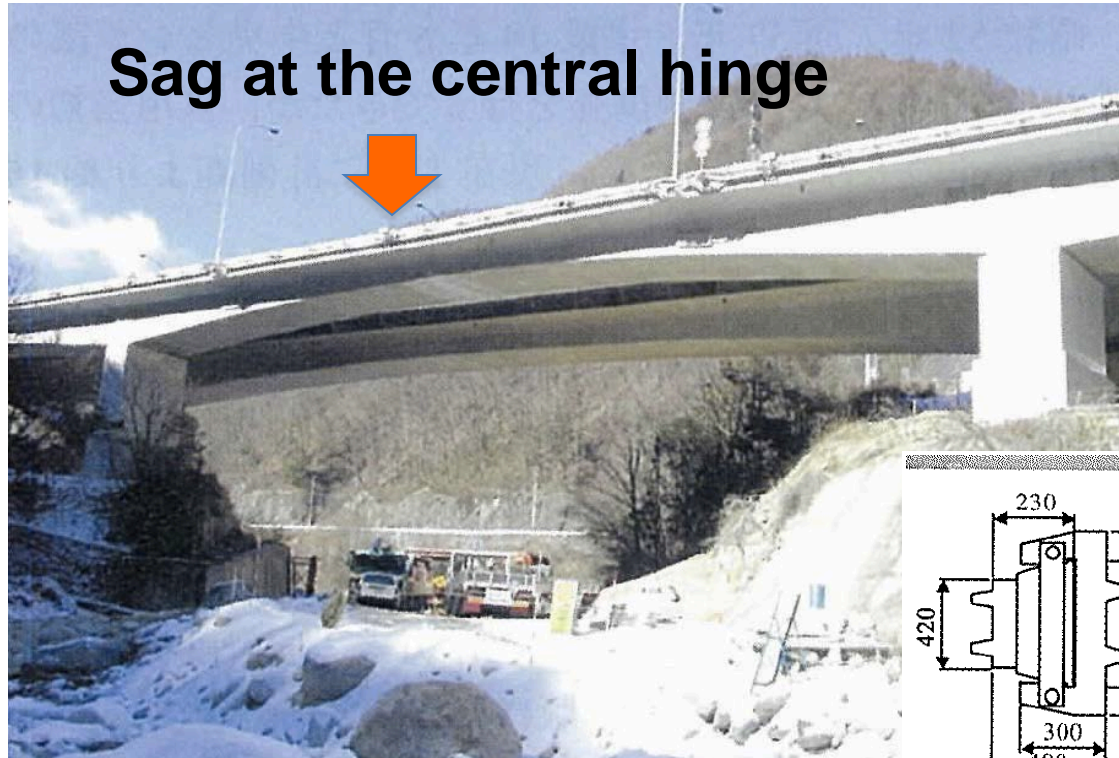
Horizontal metal bearing

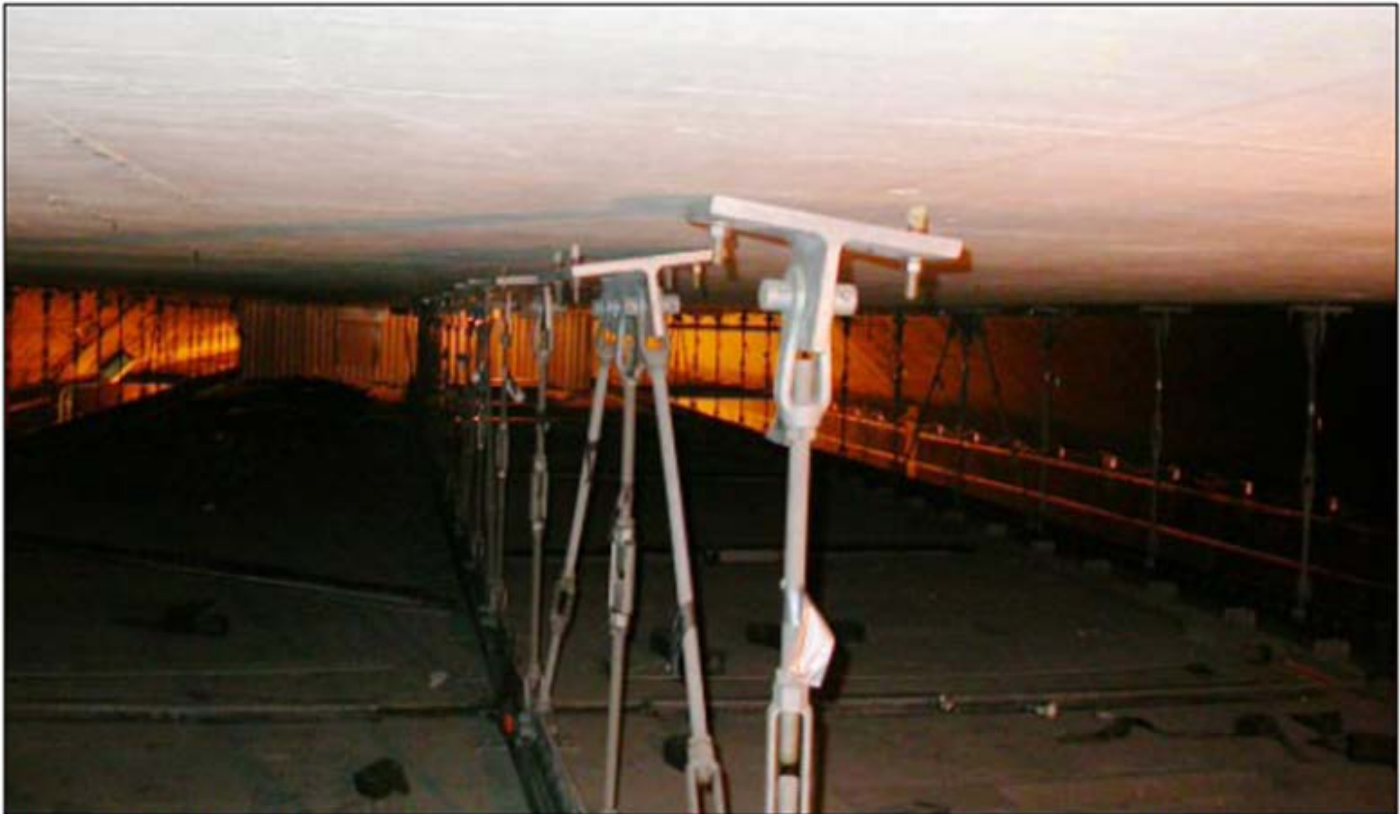
Figure 10. This photograph, taken in the westbound D Street portal tunnel after the accident, shows a number of roof hanger plates that have begun to pull away from the tunnel roof, including the two-anchor hanger plate in the foreground and the four-anchor plate adjacent to it.

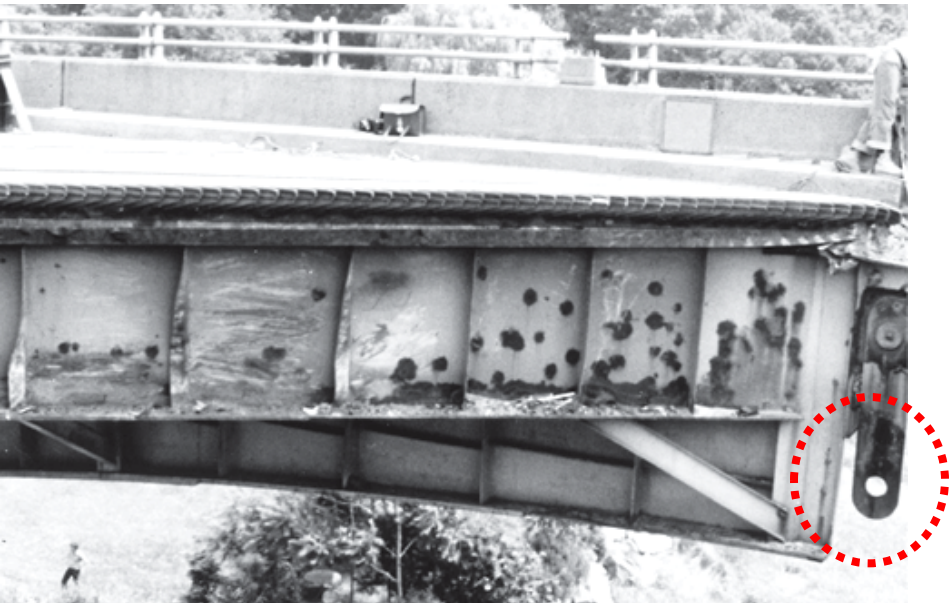
I-95 Mianus River Bridge
